Manhole Inspection Summary

Manhole # S29I__024MH

Insp Date: **9/11/08 8:00 AM**

Location Address: **647 W. Pratt St**

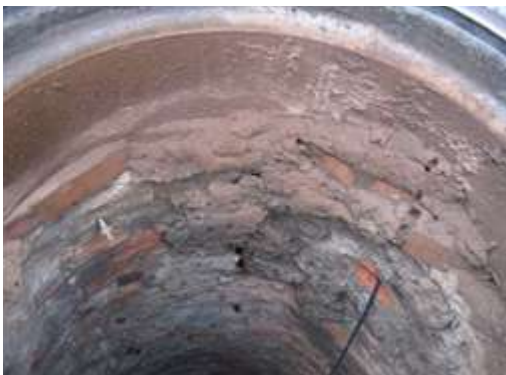
Defect 5

Frame Offset: **0** (in.) Condition: ☐ Sound ☐ Cracked ☒ **Leaks**

infiltration frame/lid dirt build up

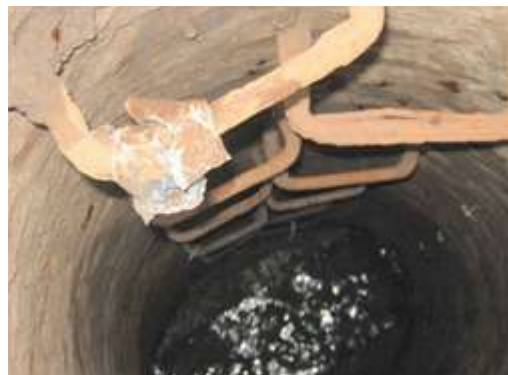
Defect 4

Surcharge ☒ **Evidence Of Surcharge** Depth: **22** (ft.) ☐ Active Surcharge Present

surcharge 22ft

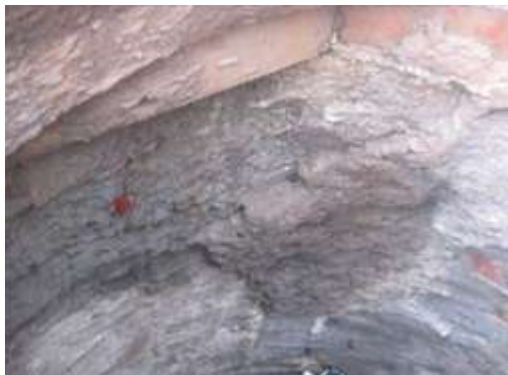
Defect 3

Condition: ☐ Sound ☐ Cracked ☐ Root Intrusion ☐ Loose Brick ☒ **Deteriorated**

Infiltration: ☐ None ☒ **Joint** ☐ Cracks ☐ Mortar ☐ Roots ☐ Wall

chimney/ frame infiltration

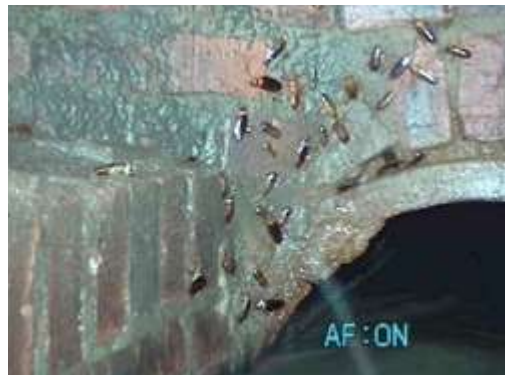
Defect 1

six o'clock pipe infiltration

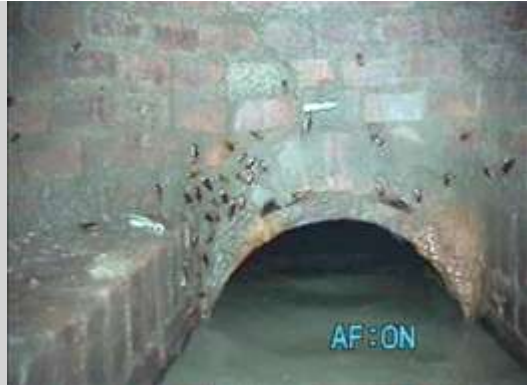
12 O'Clock Outflow

infiltration around wall of pipe

Pipe Height: **18** (in.) Rod and Bar (Angled)
Pipe Material: **Clay** ☐ Pipe Lined
Invert Depth: **17.54** (ft.) Flow Characteristics: **Turbulent**
Deposits: ☐ None ☐ Mud ☒ **Sludge** ☒ **Debris** ☐ Grease
Silt Depth: **4** (in.) Deposits Extent: **Heavy**
Infiltration: **Evidence** Pipe Seal Cond: **Unknown**

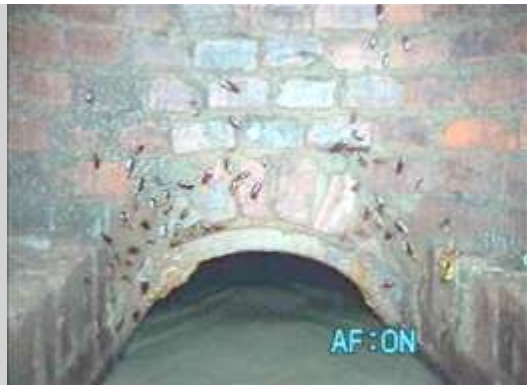
6 O'Clock Inflow

infiltration around wall of pipe

Pipe Height: **19.2** (in.) Rod and Bar (Angled)
Pipe Material: **Clay** ☐ Pipe Lined
Invert Depth: **17.64** (ft.) Flow Characteristics: **Fast**
Deposits: ☐ None ☐ Mud ☒ **Sludge** ☐ Debris ☐ Grease
Silt Depth: **4** (in.) Deposits Extent: **Heavy**
Infiltration: **Evidence** Pipe Seal Cond: **Unknown**
